CONCRETE REPAIR AND PROTECTION SYSTEM

INDEX	PAGE
Concrete and Our Environment	2
Diagnosing the Damage	4
System Products	5
Diagnosis 1 Performance Standard -New Concrete	6
Diagnosis 2 Performance Standard -Heavy dirt contamination and growths	7
Diagnosis 3 Performance Standard -Concrete with efflorescence	8
Diagnosis 4 Performance Standard -Crumbling concrete surface	9
Diagnosis 5 Performance Standard -Fine net like surface cracks	10
Diagnosis 6 Performance Standard -Concrete with flaking paint	11
Diagnosis 7 Performance Standard -Sandy friable surface	12
Diagnosis 8 Performance Standard -Sandy surface with heavy algae growth	13
Diagnosis 9 Performance Standard -Scaling concrete surface	14
Diagnosis 10 Performance Standard -Severe damage, concrete spalling	15
Performance Standard -EC-2000 on mineral facades	16

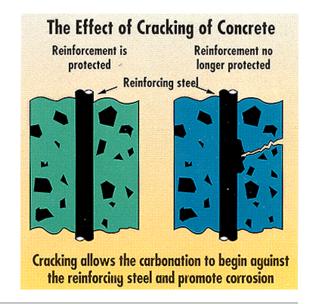
Acid rain places high demands on concrete structures. Corrosion starts when the pH value of the concrete falls below 10 and it is at this point that the damage to the structure becomes obvious.

Carbonation of the concrete leaves the surface friable and unsound. Where the concrete is reinforced rust occupies a greater volume than its parent steel.

The initial hair line cracks rapidly develop into major damage as corrosion products of the steel reinforcements expand with explosive effect on the surrounding concrete.

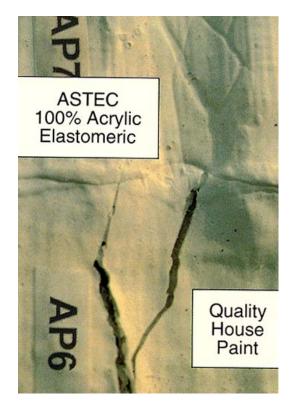
EC 2000 was designed as a sophisticated "**molecular sieve**", allowing moisture to defuse out but preventing the entry of acid gases such as Co² and So².

In addition, **EC 2000's** superior crack bridging properties offer absolute confidence in long term masonry protection, by it state of the art ability to withstand forthcoming cracks 4.9 times the dry film thickness.

(350 microns dry will accommodate a forthcoming crack of 1.75mm)

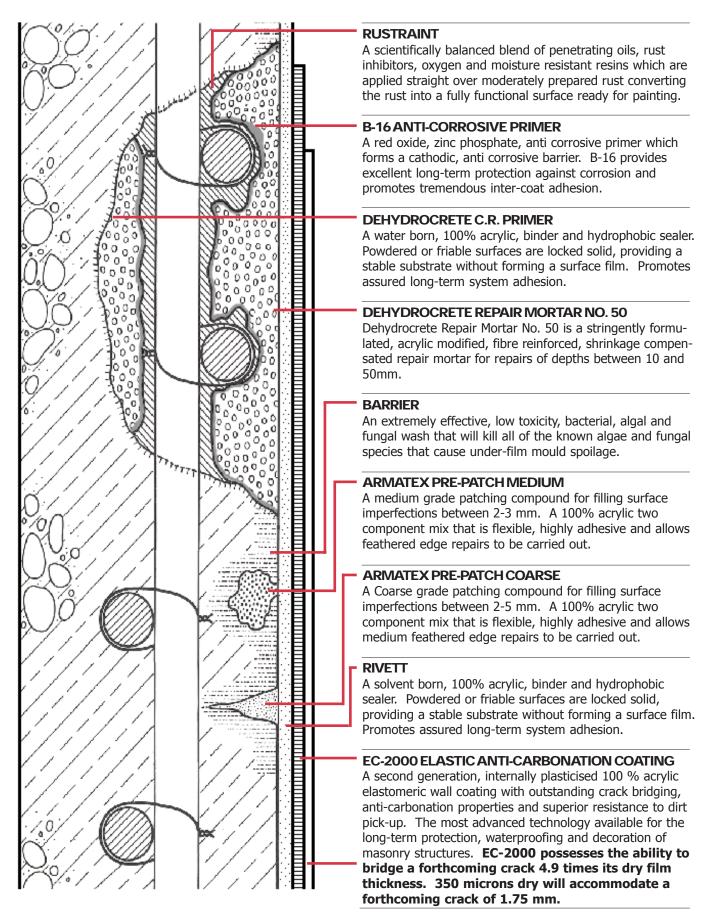
System Products

FROM REPAIRTO LONGTERM PROTECTION.
